**Asbestos Management Survey for**  
Castle Cove Sailing Club  
**at**  
Castle Cove Sailing Club  
Old Castle Road  
Weymouth  
Dorset  
DT4 8WJ

Project Number: AS11040 - Castle Cove Sailing Club

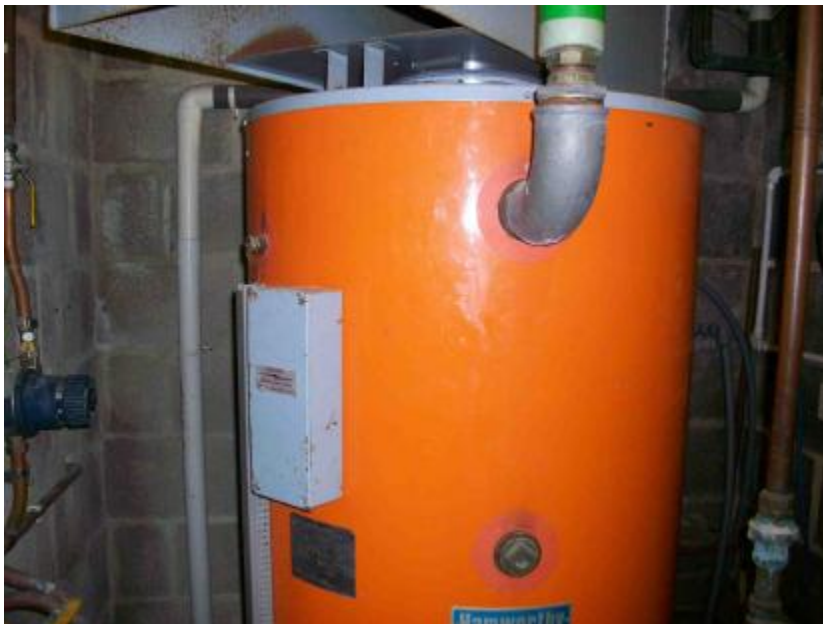
Location ID:	<input type="text" value="1410"/>	Survey Type:	<input type="text" value="MS"/>
Location Ref:	<input type="text" value="1"/>	Product Type:	<input type="text" value="Gaskets"/>
Product:	<input type="text" value="Boiler"/>	Damage:	<input type="text" value="No visible damage"/>
Area:	<input type="text" value="Not Applicable"/>	Treatment:	<input type="text" value="Composite asbestos materials"/>
Floor:	<input type="text" value="Basement"/>	Asbestos Type:	<input type="text" value="Chrysotile"/>
Room:	<input type="text" value="Boiler room"/>	Identification:	<input type="text" value="Presumed"/>
Surveyor Name:	<input type="text" value="J D Chilvers"/>	Quantity:	<input type="text"/>

Material Risk Score:	<input type="text" value="3"/>
Material Risk Band:	<input type="text" value="Very Low Risk"/>
Priority Risk Score:	<input type="text" value="2"/>

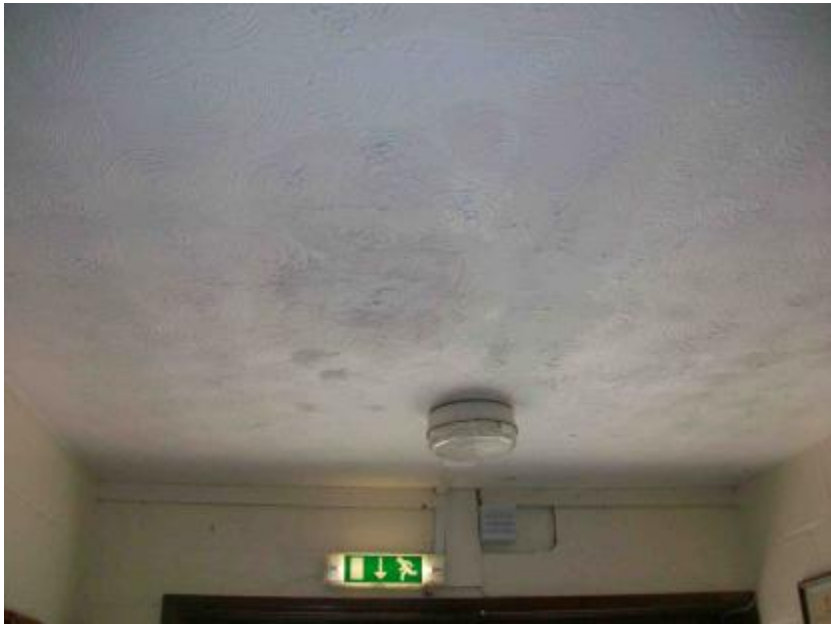
Location ID:	<input type="text" value="1411"/>	Survey Type:	<input type="text" value="MS"/>
Location Ref:	<input type="text" value="2"/>	Product Type:	<input type="text" value="NADIS"/>
Product:	<input type="text" value="Textured coating"/>	Damage:	<input type="text" value="NADIS"/>
Area:	<input type="text" value="Not Applicable"/>	Treatment:	<input type="text" value="NADIS"/>
Floor:	<input type="text" value="Ground floor"/>	Asbestos Type:	<input type="text" value="NADIS"/>
Room:	<input type="text" value="Lobby"/>	Identification:	<input type="text" value="Identified"/>
Surveyor Name:	<input type="text"/>	Quantity:	<input type="text"/>
Drawing Ref:	<input type="text" value="2"/>	Accessibility:	<input type="text"/>
Asbestos ?	<input type="text" value="No"/>		
Date:	<input type="text" value="23 March 2011"/>		
Next Inspection:	<input type="text" value="Not Applicable"/>

Material Risk Score:	<input type="text" value="0"/>
Material Risk Band:	<input type="text" value="NADIS"/>
Priority Risk Score:	<input type="text" value="N/A"/>

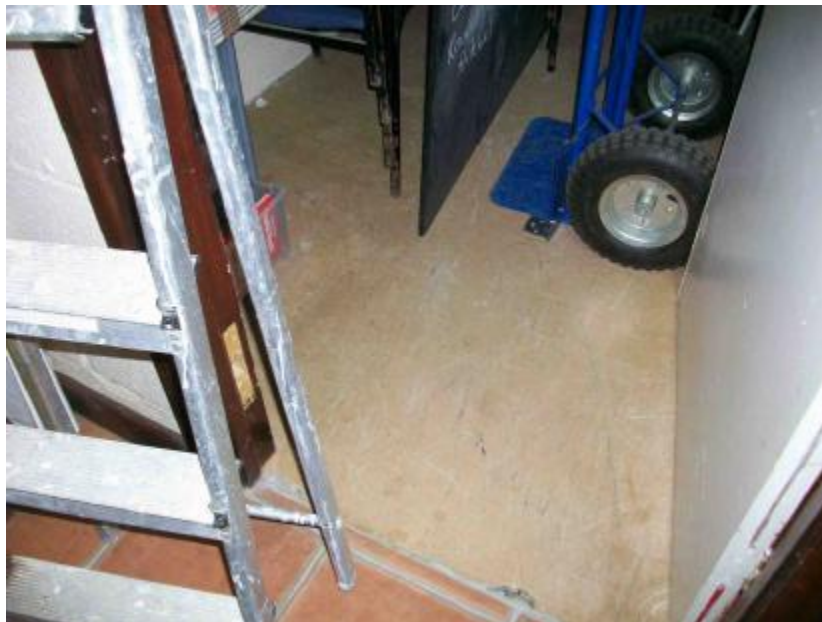
Location ID:	<input type="text" value="1413"/>	Survey Type:	<input type="text" value="MS"/>
Location Ref:	<input type="text" value="4"/>	Product Type:	<input type="text" value="Vinyl floor tiles"/>
Product:	<input type="text" value="Floor tiles"/>	Damage:	<input type="text" value="Low damage"/>
Area:	<input type="text" value="Not Applicable"/>	Treatment:	<input type="text" value="Vinyl tiles"/>
Floor:	<input type="text" value="Ground floor"/>	Asbestos Type:	<input type="text" value="Chrysotile"/>
Room:	<input type="text" value="Store Room"/>	Identification:	<input type="text" value="Presumed"/>
Surveyor Name:	<input type="text" value="J D Chilvers"/>	Quantity:	<input type="text"/>

Material Risk Score:	<input type="text" value="3"/>
Material Risk Band:	<input type="text" value="Very Low Risk"/>
Priority Risk Score:	<input type="text" value="3"/>

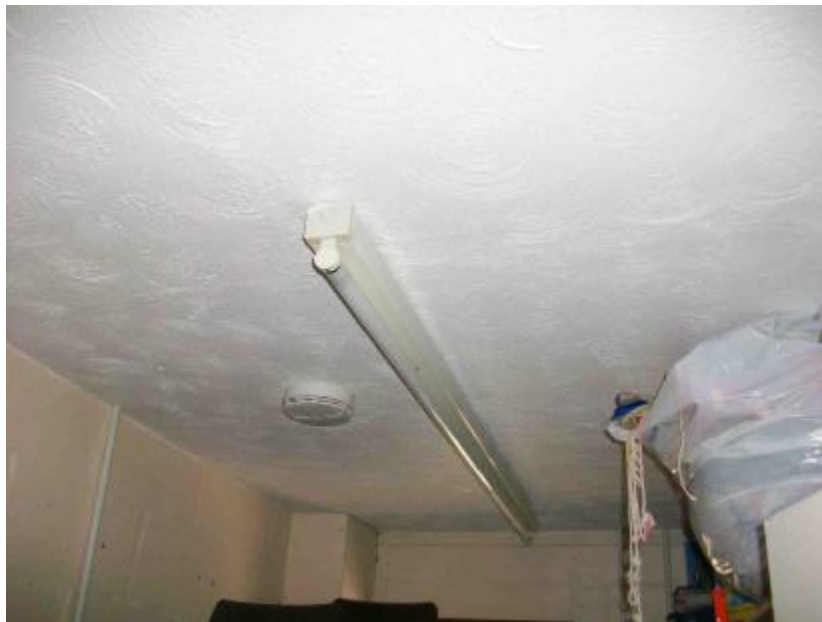
Location ID:	<input type="text" value="1414"/>	Survey Type:	<input type="text" value="MS"/>
Location Ref:	<input type="text" value="5"/>	Product Type:	<input type="text" value="NADIS"/>
Product:	<input type="text" value="Textured coating"/>	Damage:	<input type="text" value="NADIS"/>
Area:	<input type="text" value="Not Applicable"/>	Treatment:	<input type="text" value="NADIS"/>
Floor:	<input type="text" value="Ground floor"/>	Asbestos Type:	<input type="text" value="NADIS"/>
Room:	<input type="text" value="Store Room"/>	Identification:	<input type="text" value="Identified"/>
Surveyor Name:	<input type="text" value="J D Chilvers"/>	Quantity:	<input type="text"/>

Material Risk Score:	<input type="text" value="0"/>
Material Risk Band:	<input type="text" value="NADIS"/>
Priority Risk Score:	<input type="text" value="N/A"/>

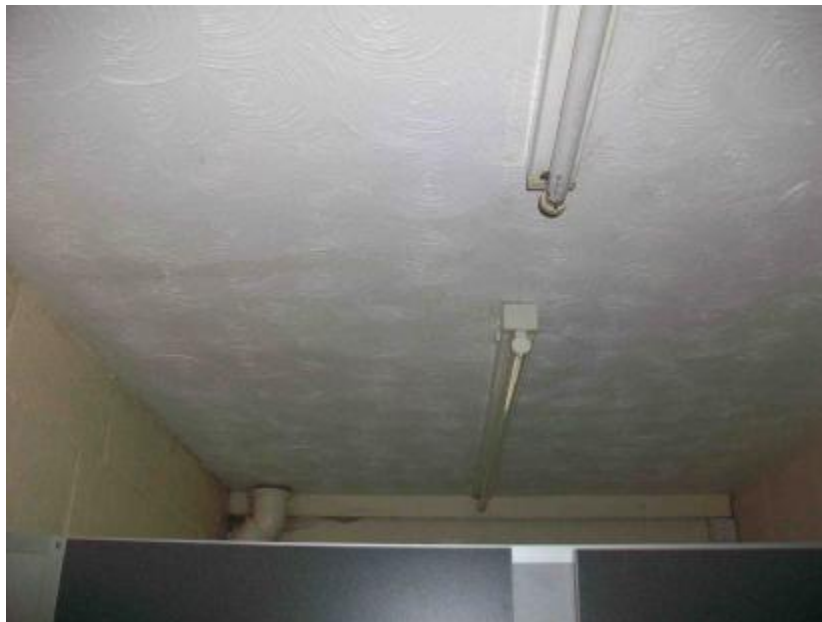
Location ID:	<input type="text" value="1415"/>	Survey Type:	<input type="text" value="MS"/>
Location Ref:	<input type="text" value="6"/>	Product Type:	<input type="text" value="NADIS"/>
Product:	<input type="text" value="Textured coating"/>	Damage:	<input type="text" value="NADIS"/>
Area:	<input type="text" value="Not Applicable"/>	Treatment:	<input type="text" value="NADIS"/>
Floor:	<input type="text" value="Ground floor"/>	Asbestos Type:	<input type="text" value="NADIS"/>
Room:	<input type="text" value="WC"/>	Identification:	<input type="text" value="Identified"/>
Surveyor Name:	<input type="text" value="J D Chilvers"/>	Quantity:	<input type="text"/>
Drawing Ref:	<input type="text" value="6"/>	Accessibility:	<input type="text"/>
Asbestos ?	<input type="text" value="No"/>		
Date:	<input type="text" value="23 March 2011"/>		
Next Inspection:	<input type="text" value="Not Applicable"/>

Material Risk Score:	<input type="text" value="0"/>
Material Risk Band:	<input type="text" value="NADIS"/>
Priority Risk Score:	<input type="text" value="N/A"/>

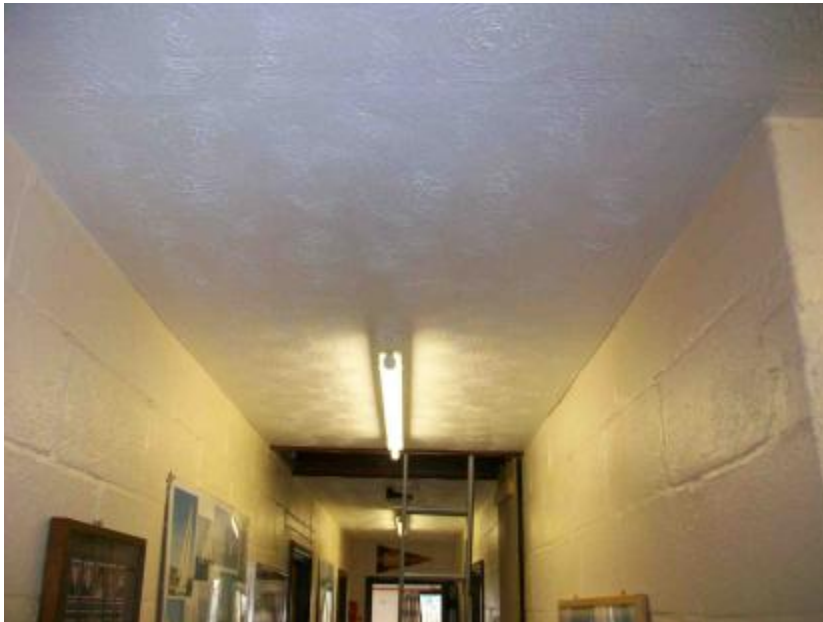
Location ID:	<input type="text" value="1416"/>	Survey Type:	<input type="text" value="MS"/>
Location Ref:	<input type="text" value="7"/>	Product Type:	<input type="text" value="NADIS"/>
Product:	<input type="text" value="Textured coating"/>	Damage:	<input type="text" value="NADIS"/>
Area:	<input type="text" value="Not Applicable"/>	Treatment:	<input type="text" value="NADIS"/>
Floor:	<input type="text" value="Ground floor"/>	Asbestos Type:	<input type="text" value="NADIS"/>
Room:	<input type="text" value="Passageway"/>	Identification:	<input type="text" value="Identified"/>
Surveyor Name:	<input type="text" value="J D Chilvers"/>	Quantity:	<input type="text"/>

Material Risk Score:	<input type="text" value="0"/>
Material Risk Band:	<input type="text" value="NADIS"/>
Priority Risk Score:	<input type="text" value="N/A"/>

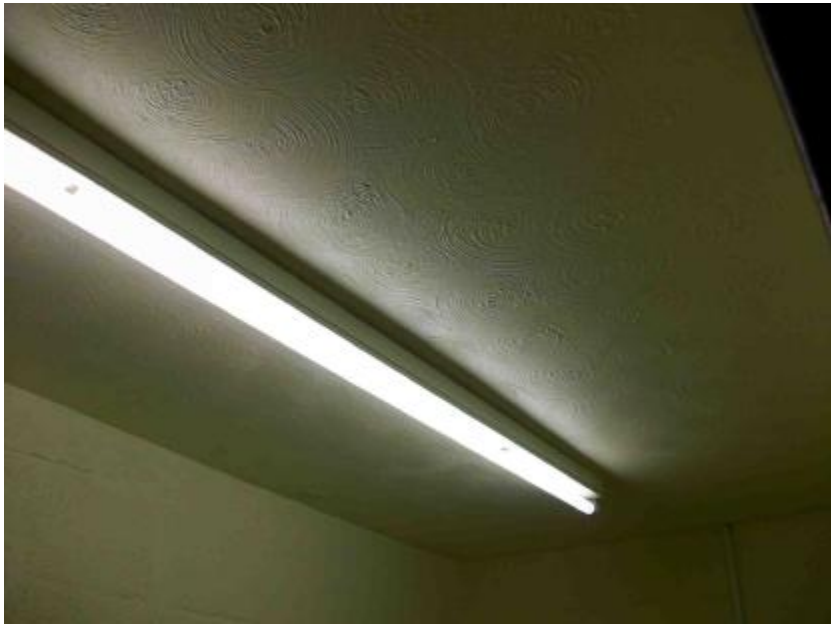
Location ID:	<input type="text" value="1417"/>	Survey Type:	<input type="text" value="MS"/>
Location Ref:	<input type="text" value="8"/>	Product Type:	<input type="text" value="NADIS"/>
Product:	<input type="text" value="Textured coating"/>	Damage:	<input type="text" value="NADIS"/>
Area:	<input type="text" value="Not Applicable"/>	Treatment:	<input type="text" value="NADIS"/>
Floor:	<input type="text" value="Ground floor"/>	Asbestos Type:	<input type="text" value="NADIS"/>
Room:	<input type="text" value="Wash up area"/>	Identification:	<input type="text" value="Identified"/>
Surveyor Name:	<input type="text" value="J D Chilvers"/>	Quantity:	<input type="text"/>

Material Risk Score:	<input type="text" value="0"/>
Material Risk Band:	<input type="text" value="NADIS"/>
Priority Risk Score:	<input type="text" value="N/A"/>

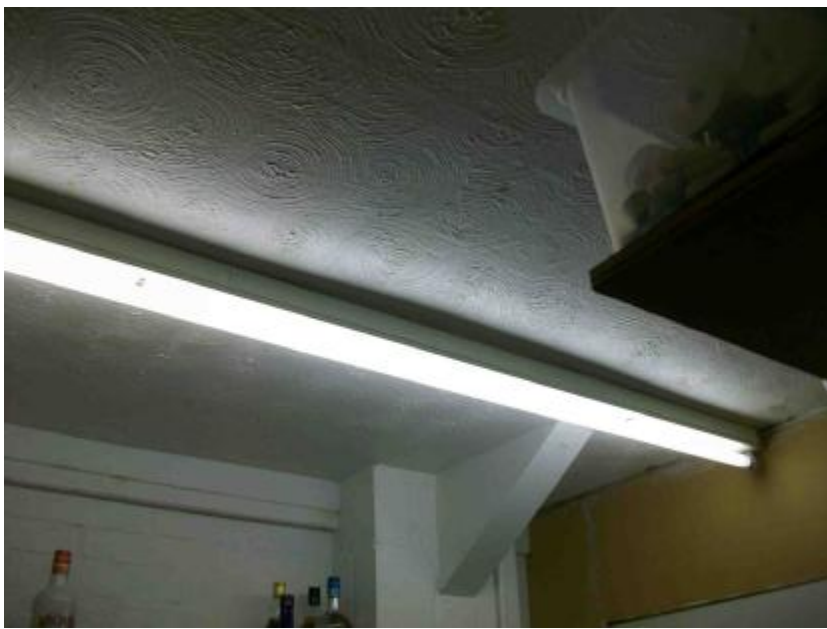
Location ID:	<input type="text" value="1418"/>	Survey Type:	<input type="text" value="MS"/>
Location Ref:	<input type="text" value="9"/>	Product Type:	<input type="text" value="NADIS"/>
Product:	<input type="text" value="Textured coating"/>	Damage:	<input type="text" value="NADIS"/>
Area:	<input type="text" value="Not Applicable"/>	Treatment:	<input type="text" value="NADIS"/>
Floor:	<input type="text" value="Ground floor"/>	Asbestos Type:	<input type="text" value="NADIS"/>
Room:	<input type="text" value="Cellar"/>	Identification:	<input type="text" value="Identified"/>
Surveyor Name:	<input type="text" value="J D Chilvers"/>	Quantity:	<input type="text"/>

Material Risk Score:	<input type="text" value="0"/>
Material Risk Band:	<input type="text" value="NADIS"/>
Priority Risk Score:	<input type="text" value="N/A"/>

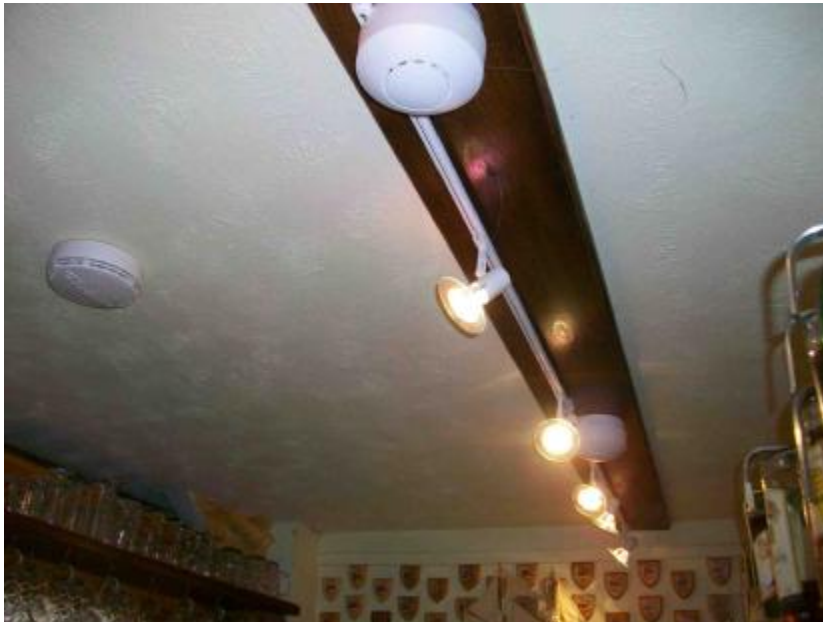
Location ID:	<input type="text" value="1419"/>	Survey Type:	<input type="text" value="MS"/>
Location Ref:	<input type="text" value="10"/>	Product Type:	<input type="text" value="NADIS"/>
Product:	<input type="text" value="Textured coating"/>	Damage:	<input type="text" value="NADIS"/>
Area:	<input type="text" value="Not Applicable"/>	Treatment:	<input type="text" value="NADIS"/>
Floor:	<input type="text" value="Ground floor"/>	Asbestos Type:	<input type="text" value="NADIS"/>
Room:	<input type="text" value="Bar area"/>	Identification:	<input type="text" value="Identified"/>
Surveyor Name:	<input type="text" value="J D Chilvers"/>	Quantity:	<input type="text"/>

Material Risk Score:	<input type="text" value="0"/>
Material Risk Band:	<input type="text" value="NADIS"/>
Priority Risk Score:	<input type="text" value="N/A"/>

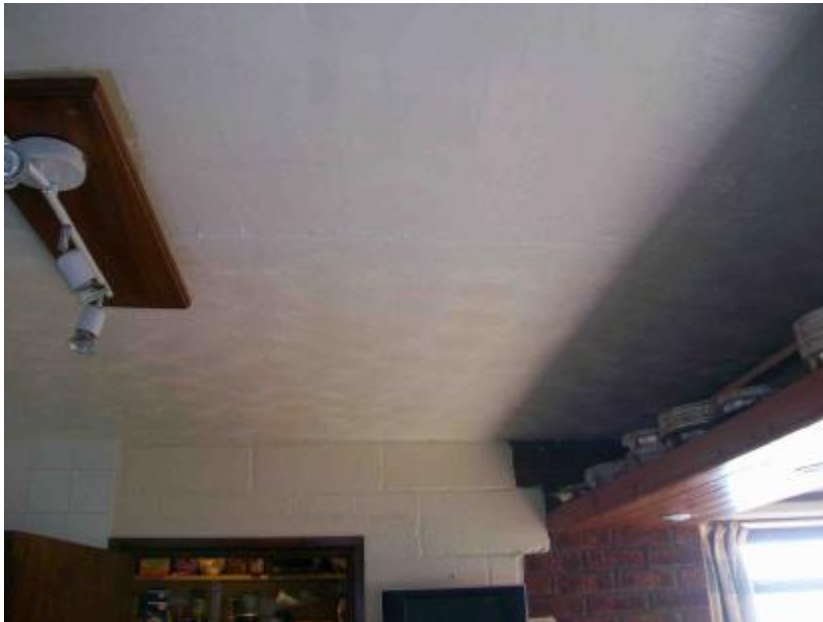
Location ID:	<input type="text" value="1420"/>	Survey Type:	<input type="text" value="MS"/>
Location Ref:	<input type="text" value="11"/>	Product Type:	<input type="text" value="NADIS"/>
Product:	<input type="text" value="Textured coating"/>	Damage:	<input type="text" value="NADIS"/>
Area:	<input type="text" value="Not Applicable"/>	Treatment:	<input type="text" value="NADIS"/>
Floor:	<input type="text" value="Ground floor"/>	Asbestos Type:	<input type="text" value="NADIS"/>
Room:	<input type="text" value="Function Room"/>	Identification:	<input type="text" value="Identified"/>
Surveyor Name:	<input type="text" value="J D Chilvers"/>	Quantity:	<input type="text"/>

Material Risk Score:	<input type="text" value="0"/>
Material Risk Band:	<input type="text" value="NADIS"/>
Priority Risk Score:	<input type="text" value="N/A"/>

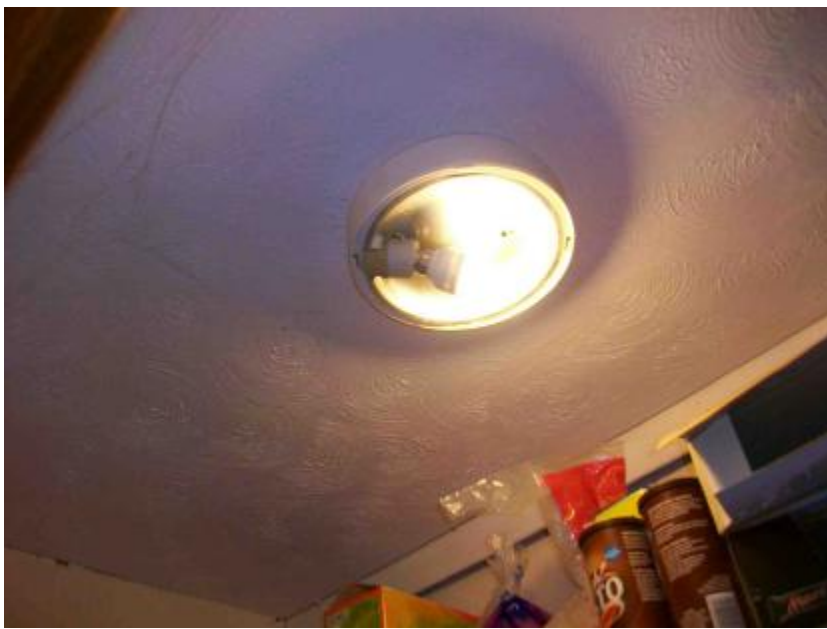
Location ID:	<input type="text" value="1421"/>	Survey Type:	<input type="text" value="MS"/>
Location Ref:	<input type="text" value="12"/>	Product Type:	<input type="text" value="NADIS"/>
Product:	<input type="text" value="Textured coating"/>	Damage:	<input type="text" value="NADIS"/>
Area:	<input type="text" value="Not Applicable"/>	Treatment:	<input type="text" value="NADIS"/>
Floor:	<input type="text" value="Ground floor"/>	Asbestos Type:	<input type="text" value="NADIS"/>
Room:	<input type="text" value="Cupboard"/>	Identification:	<input type="text" value="Identified"/>
Surveyor Name:	<input type="text" value="J D Chilvers"/>	Quantity:	<input type="text"/>

Material Risk Score:	<input type="text" value="0"/>
Material Risk Band:	<input type="text" value="NADIS"/>
Priority Risk Score:	<input type="text" value="N/A"/>

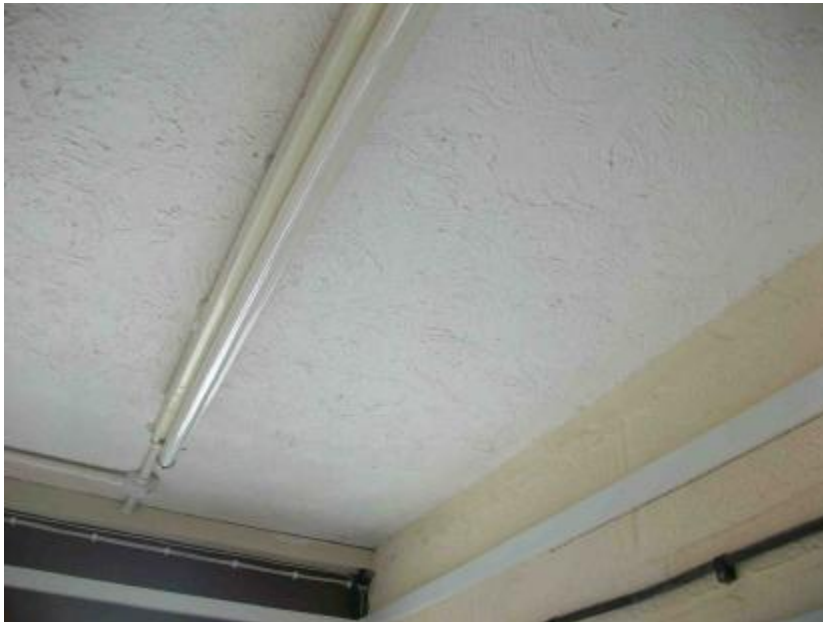
Location ID:	<input type="text" value="1422"/>	Survey Type:	<input type="text" value="MS"/>
Location Ref:	<input type="text" value="13"/>	Product Type:	<input type="text" value="NADIS"/>
Product:	<input type="text" value="Textured coating"/>	Damage:	<input type="text" value="NADIS"/>
Area:	<input type="text" value="Not Applicable"/>	Treatment:	<input type="text" value="NADIS"/>
Floor:	<input type="text" value="Basement"/>	Asbestos Type:	<input type="text" value="NADIS"/>
Room:	<input type="text" value="Lobby"/>	Identification:	<input type="text"/>
Surveyor Name:	<input type="text" value="J D Chilvers"/>	Quantity:	<input type="text"/>
Drawing Ref:	<input type="text" value="13"/>	Accessibility:	<input type="text"/>
Asbestos ?	<input type="text" value="No"/>		
Date:	<input type="text" value="23 March 2011"/>		
Next Inspection:	<input type="text" value="Not Applicable"/>

Material Risk Score:	<input type="text" value="0"/>
Material Risk Band:	<input type="text" value="NADIS"/>
Priority Risk Score:	<input type="text" value="N/A"/>

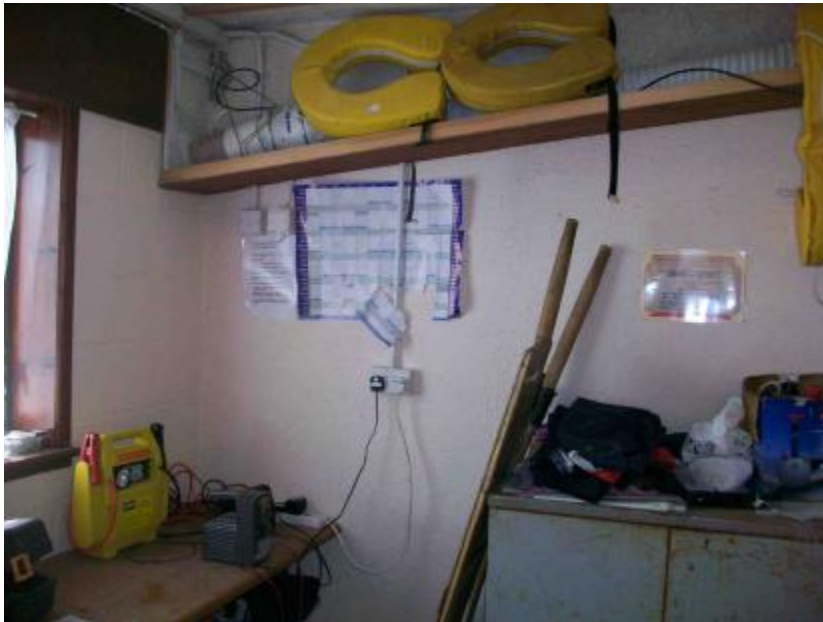
Location ID:	<input type="text" value="1423"/>	Survey Type:	<input type="text" value="MS"/>
Location Ref:	<input type="text" value="14"/>	Product Type:	<input type="text" value="NADIS"/>
Product:	<input type="text" value="Textured coating"/>	Damage:	<input type="text" value="NADIS"/>
Area:	<input type="text" value="Not Applicable"/>	Treatment:	<input type="text" value="NADIS"/>
Floor:	<input type="text" value="Basement"/>	Asbestos Type:	<input type="text" value="NADIS"/>
Room:	<input type="text" value="Workshop"/>	Identification:	<input type="text" value="Identified"/>
Surveyor Name:	<input type="text" value="J D Chilvers"/>	Quantity:	<input type="text"/>

Material Risk Score:	<input type="text" value="0"/>
Material Risk Band:	<input type="text" value="NADIS"/>
Priority Risk Score:	<input type="text" value="N/A"/>

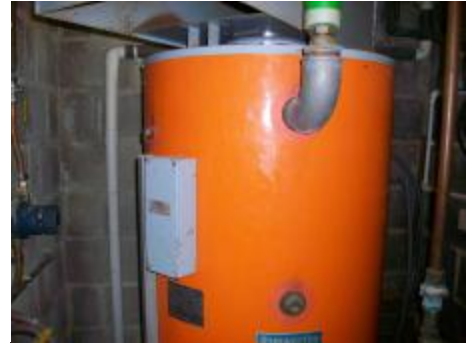
Asbestos ? Yes

Priority Assessment Algorithm			
Assessment factor	Variable(s) selected	Score for each variable	Overall score
<b>Normal Occupant Activity:</b>			
Main type of activity in area:	Rare disturbance	0	average
Secondary activities for area:	Rare disturbance	0	0
<b>Likelihood Of Disturbance:</b>			
Location:	Rooms up to 100 m2	2	
Accessibility:	Usually inaccessible or unlikely to be disturbed	0	average
Extent/Amount:	Small items strings gaskets	0	1
<b>Human Exposure Potential:</b>			
Number of occupants:	1 to 3	1	
Frequency of use of area:	Weekly	2	average
Average time area is in use:	<1 hour	0	1
<b>Maintenance Activity:</b>			
Type of maintenance activity:	Minor disturbance	0	average
Frequency of maintenance activity:	Unlikely to be disturbed	0	0

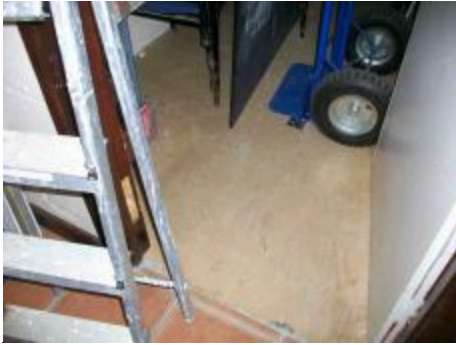
Location ID:	1413
Location Ref:	4
Product:	Floor tiles
Area:	Not Applicable
Floor:	Ground floor
Room:	Store Room
Surveyor Name:	J D Chilvers
Drawing Ref:	4
Asbestos ?	Yes
Date:	23 March 2011

Priority Assessment Algorithm	Variable(s) selected	Score for each variable	Overall score
<b>Normal Occupant Activity:</b>			
Main type of activity in area:	Low disturbance	1	average 1
Secondary activities for area:	Rare disturbance	0	
<b>Likelihood Of Disturbance:</b>			
Location:	Rooms up to 100 m2	2	average 1
Accessibility:	Usually inaccessible or unlikely to be disturbed	0	
Extent/Amount:	<=10 m2 or <=10 m pipe run	1	
<b>Human Exposure Potential:</b>			
Number of occupants:	1 to 3	1	average 1
Frequency of use of area:	Daily	3	
Average time area is in use:	<1 hour	0	
<b>Maintenance Activity:</b>			
Type of maintenance activity:	Minor disturbance	0	average 0
Frequency of maintenance activity:	Unlikely to be disturbed	0
